## Development of Second and Third Generation Corvette Steering Couplers

ARTICLE BY **TOM KRAUSE** • NCRS #63300  
UNLESS NOTED -  
PHOTOS COURTESY OF **ENGINEEREDSPARES.COM**

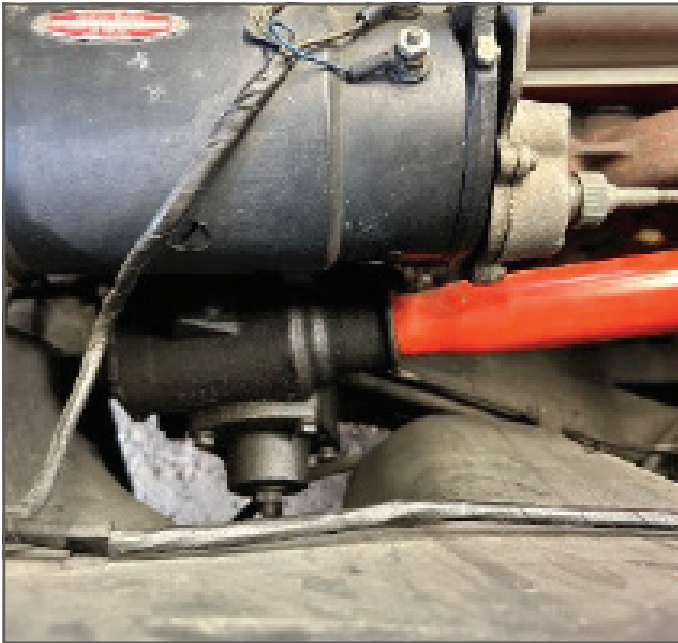
Beginning with the 1963 model year, the second generation of the Corvette was the first to use a flexible steering coupling (rag joint). The C1 Corvette steering column was connected directly to the Steering Gearbox with no flexible coupling between them.

**Generic C1 Steering Shaft Connection\***

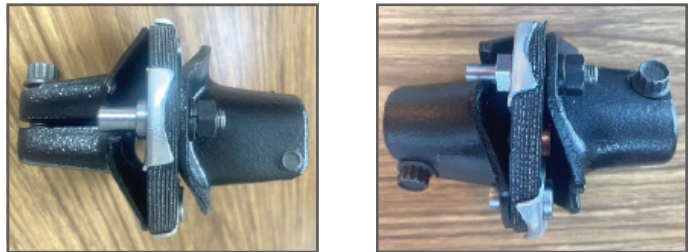
The other casting was held to the rubber disc with special bolts. The bolt threads were 5/16-24 UNF and a lock washer was used beneath the nuts. The bolts had round flat heads similar to the rivets, but with a round pin extending up from the

bolt head far enough to engage the cast slots in the riveted casting. This meant that even if there were a complete failure of the rubber disc, the pins mounted to the bolted casting would extend through the riveted casting to provide a means to steer the car. There would be significant play in the wheel, enough that any reasonable driver would have the steering checked. The pins on the bolt heads were the same length, but two different diameters.

There is a frequent design variation noted in these special bolts. The alternate design was of the same length, thread size and pin diameters, but the round head was changed to a 1/2" wide hex. This author has not been able to find any mention of the different bolt shapes in NCRS Technical Discussion Board Posts, or other online forums. Both designs have been seen on multiple Corvettes throughout C2 production. This author assumes that there was an optional construction specified on the drawing, and some manufacturers chose one or the other. More observations and research are needed.

**1963-1966 Steering Coupling with Non-Telescoping steering shafts. Note bolt head (round and hex) extending through slot in casting.**

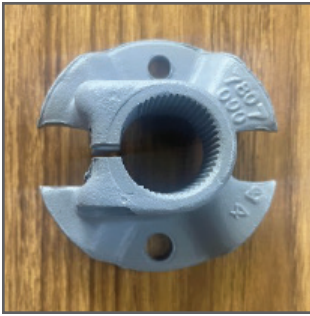
The collapsible steering column also introduced a larger 1" diameter steering shaft with a 48-count spline for 1967. This change required a new flange for the steering shaft side of the steering coupling. This new casting was P/N 7807000 (again only relevant as to the SSG casting). This casting number has been seen with two somewhat different cast shapes, but the functional surfaces are identical.

**Shape 'A' of  
casting 7807000**

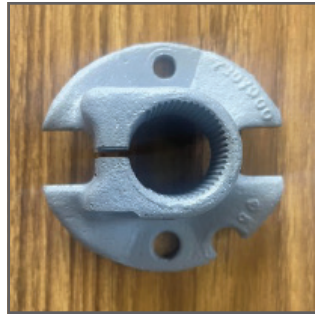
**Shape 'B' of  
casting 7807000**

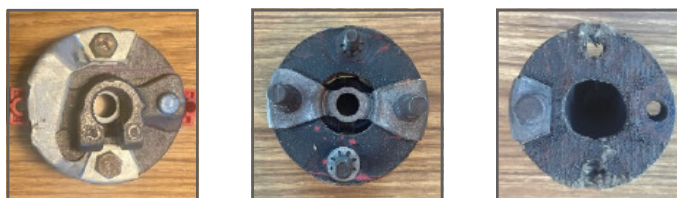
Steering Couplings that were sold as service parts may be identified by the color coding on the face of the rubber disc. The practice of Saginaw Steering Gear was to adopt production improvements for service parts as time went on. For example, steering couplings made as service parts for C2 and C3 cars that originally had copper ground straps were produced with the wire mesh grounding method after the wire mesh was introduced into production parts in 1971. To assure fitment, the flanges and machining stayed the same for service parts, but everything else was updated to the latest production version.

Three different service Steering Couplers – The one on the left is NOS and never installed. The one in the middle is a C3 with a one-piece reinforcing plate. The one on the right is a C2 with a wire mesh ground (introduced after 1971). Note paint on discs and on formed rivet heads

Per a comment from Jim Shea, the paint daubs on the formed ends of the rivets was not done on production couplers until the late 1970's (actual date is uncertain). This indicates that for all C2 and early 70's C3 Corvettes, only service couplings would have this paint mark on the rivet not the parts that were used for production.

Different paint colors were used on the C2 flexible rubber discs to identify the various types, but again only on service parts. As mentioned earlier, all Corvettes used 7 ply discs. The paint has been seen fully covering one side of the disc, or as if the

paint had been allowed to drip on one side of the disc leaving colored stripes. This color code was also used on C3 service couplings. The colors used were as follows:

- Yellow Paint - 7 ply disc without screen
- Purple Paint - 4 ply disc without screen
- Orange (Red) Paint - 7 ply disc with screen
- No Paint - 4 ply with screen
